NASA Simulation Activities Supporting the Columbia Accident Investigation and Space Shuttle Return to Flight

Dr. Woodrow Whitlow, Jr.

NASA Kennedy Space Center

June 28, 2004

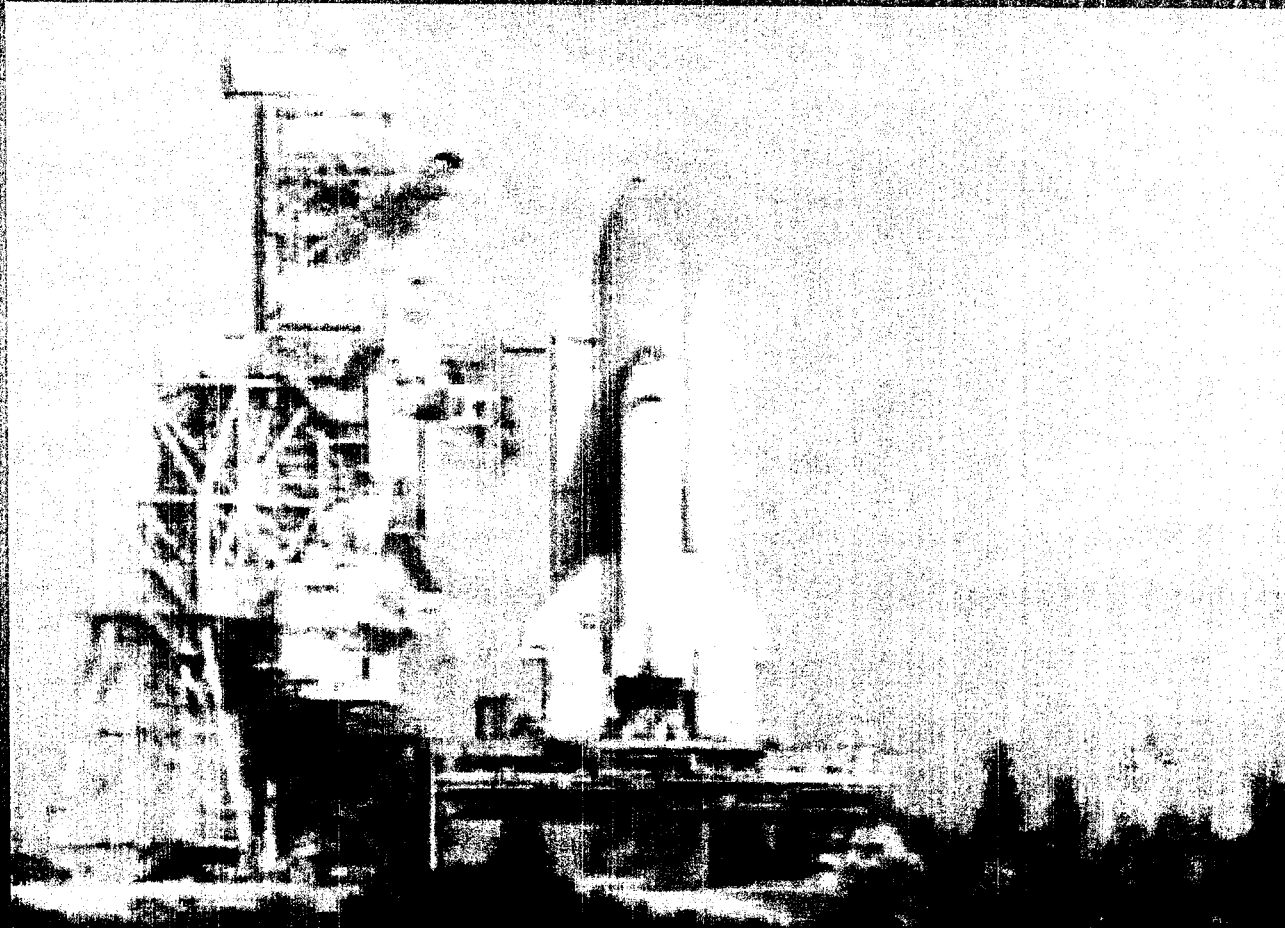
On January 16 2003, Columbia's leading edge was impacted by a piece of foam suspected to have separated from the external tank bipod ramp at 81 seconds into its launch.

Columbia was traveling at Mach 2.46, at an altitude of 65,860 feet. The foam was calculated to have hit the orbiter at 700 – 800 feet per second

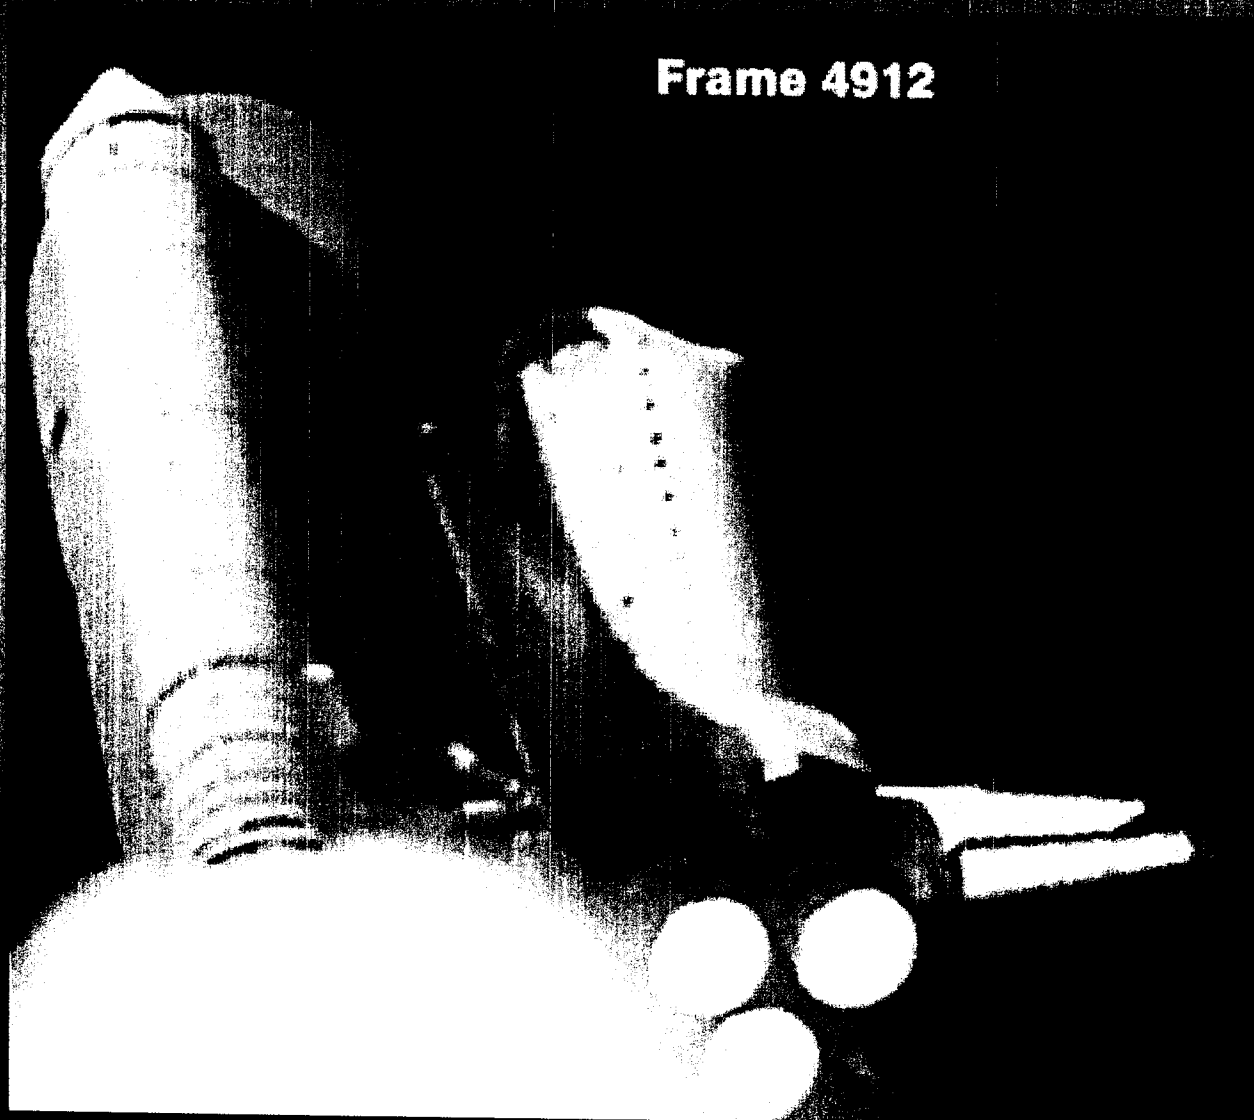
Frame 4912

Insulating Foam Separates from Bipod Ramp and Impacts Left Wing of Columbia

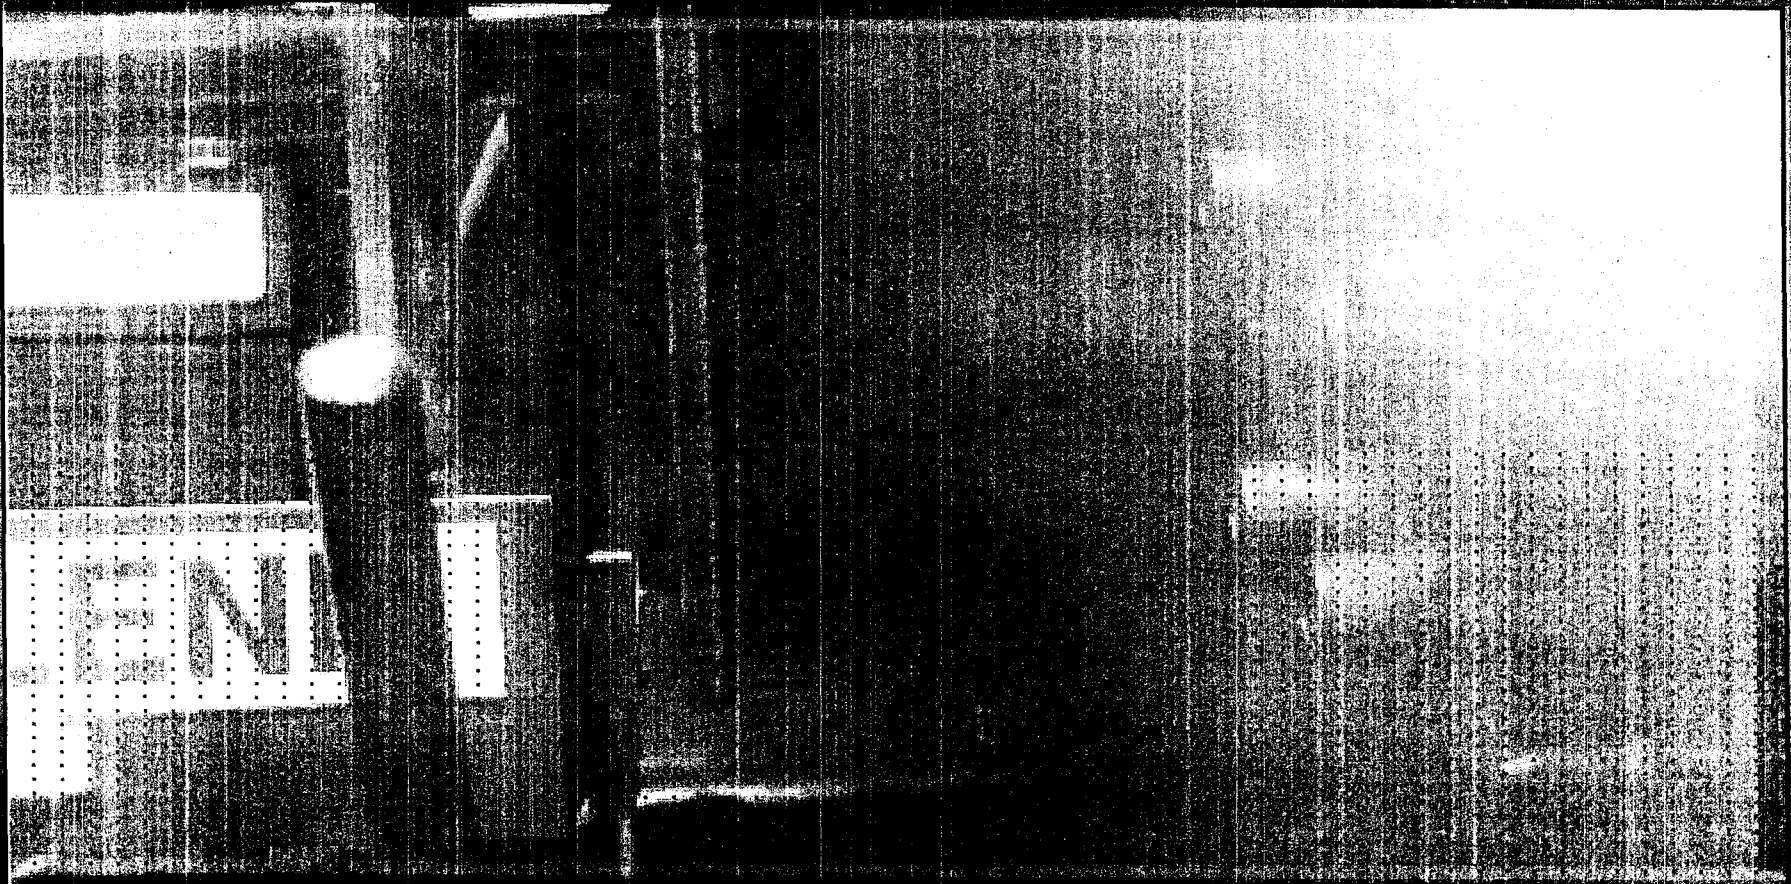
Foam Fractures RCC coupon in half at 695 ft/sec

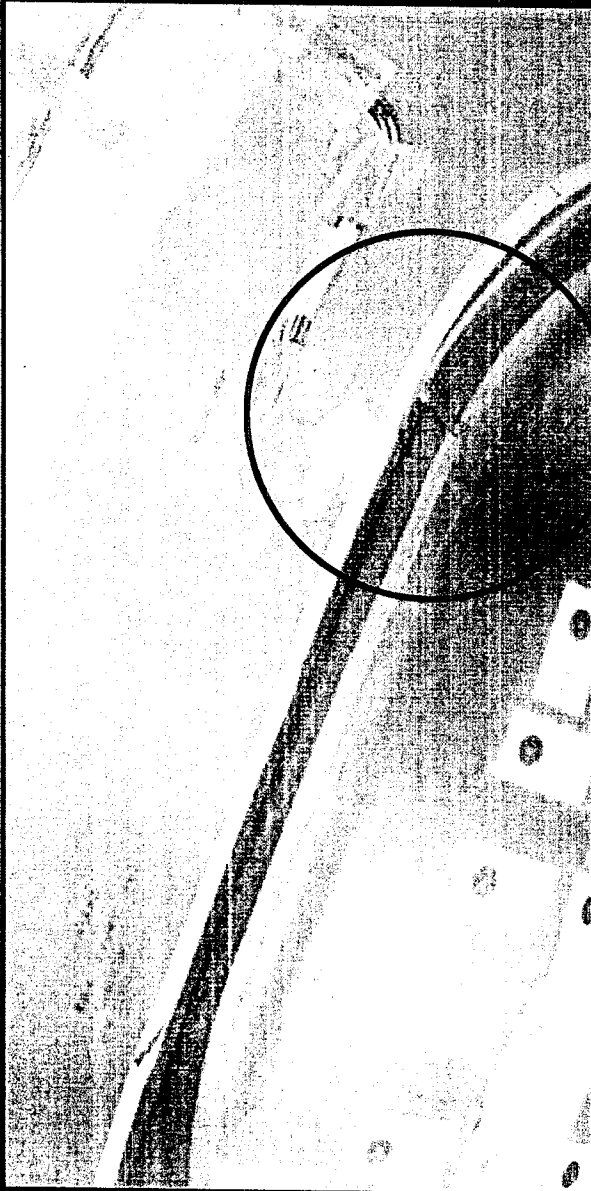
**Internal View of RCC
Panel 6 Test shows
crack form in rib**

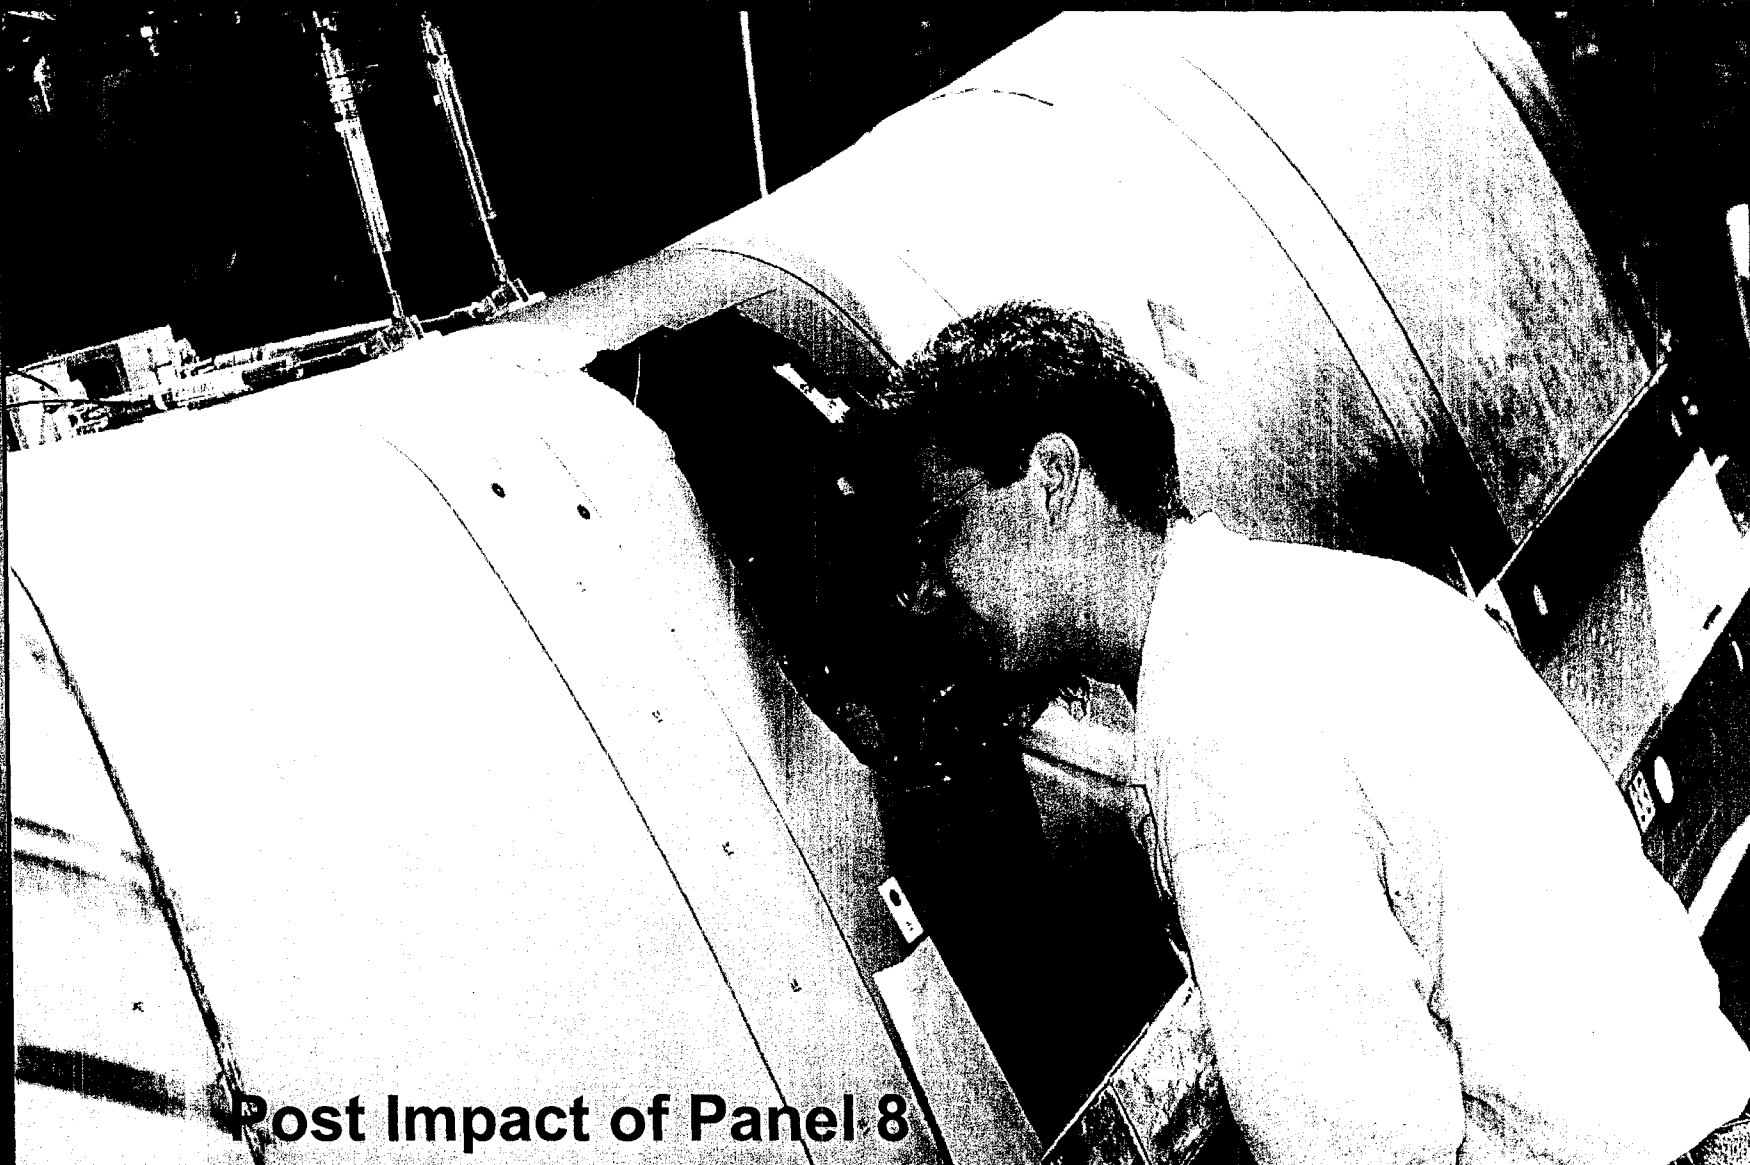
Post Impact of Panel 8

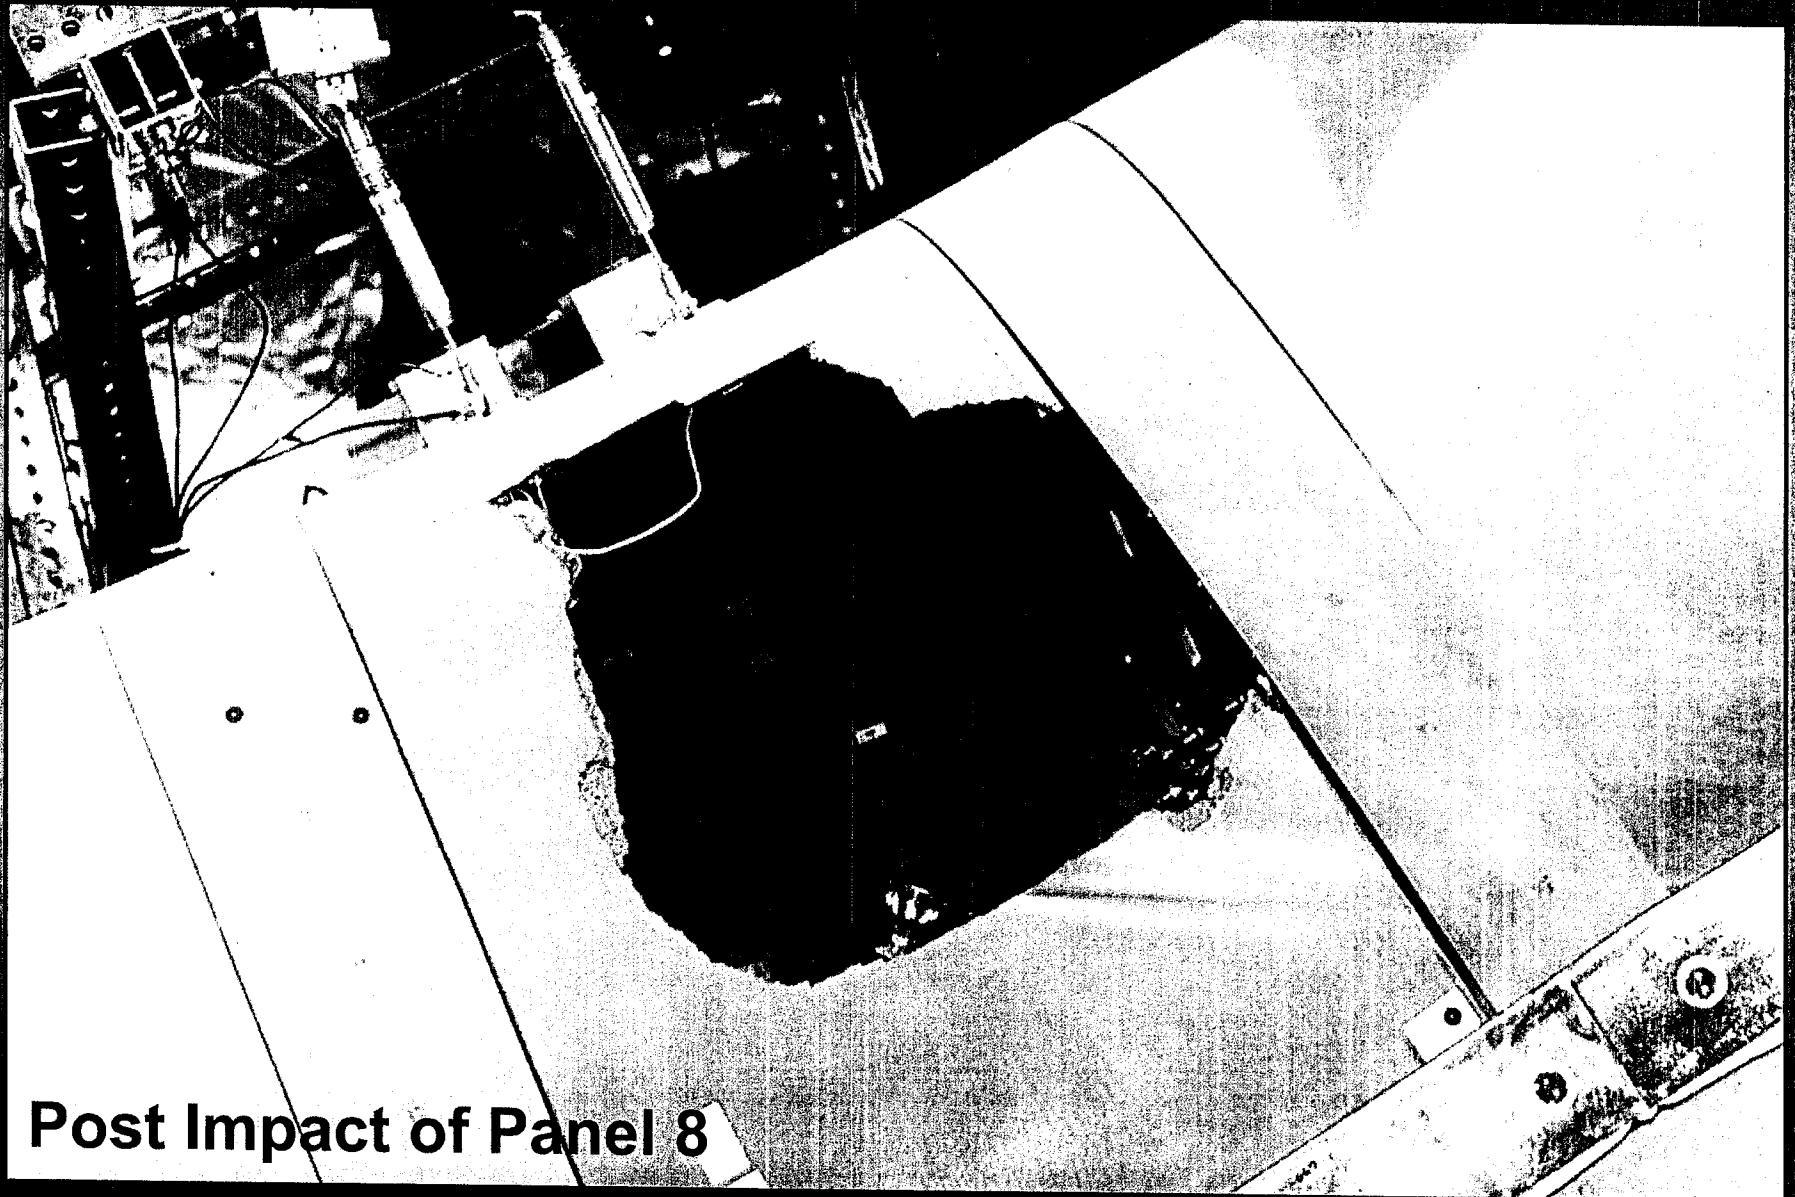
Post Impact of Panel 8

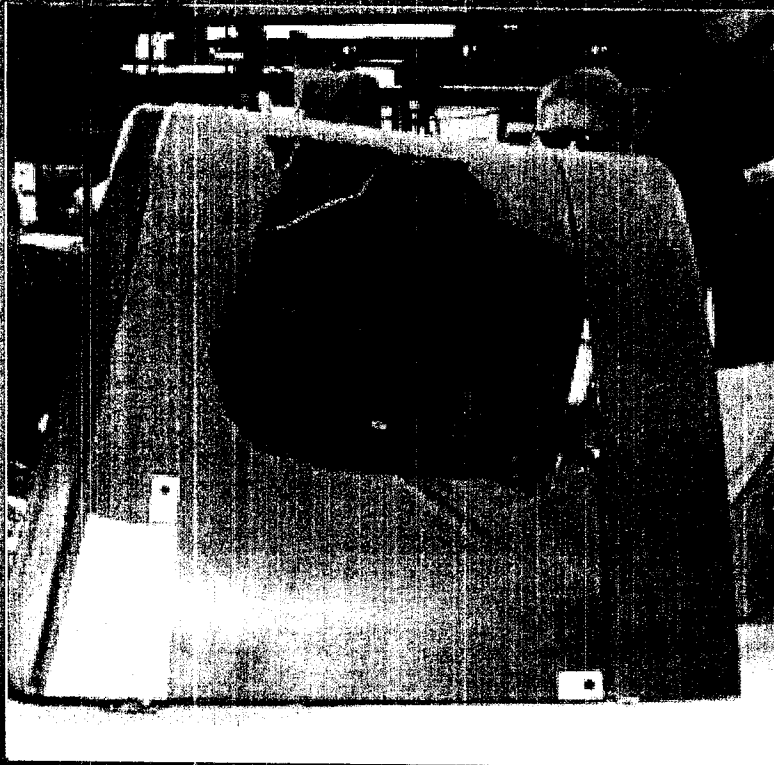
Panel 8, post-test

**Part of
foam
debris**
